| Subject: WHITE OR BLUE SMOKE FROM TAIL PIPE AFTER LONG IDLE PERIOD | Bulletin No: 01-002/11 |
| | Last Issued: 04/21/2011 |

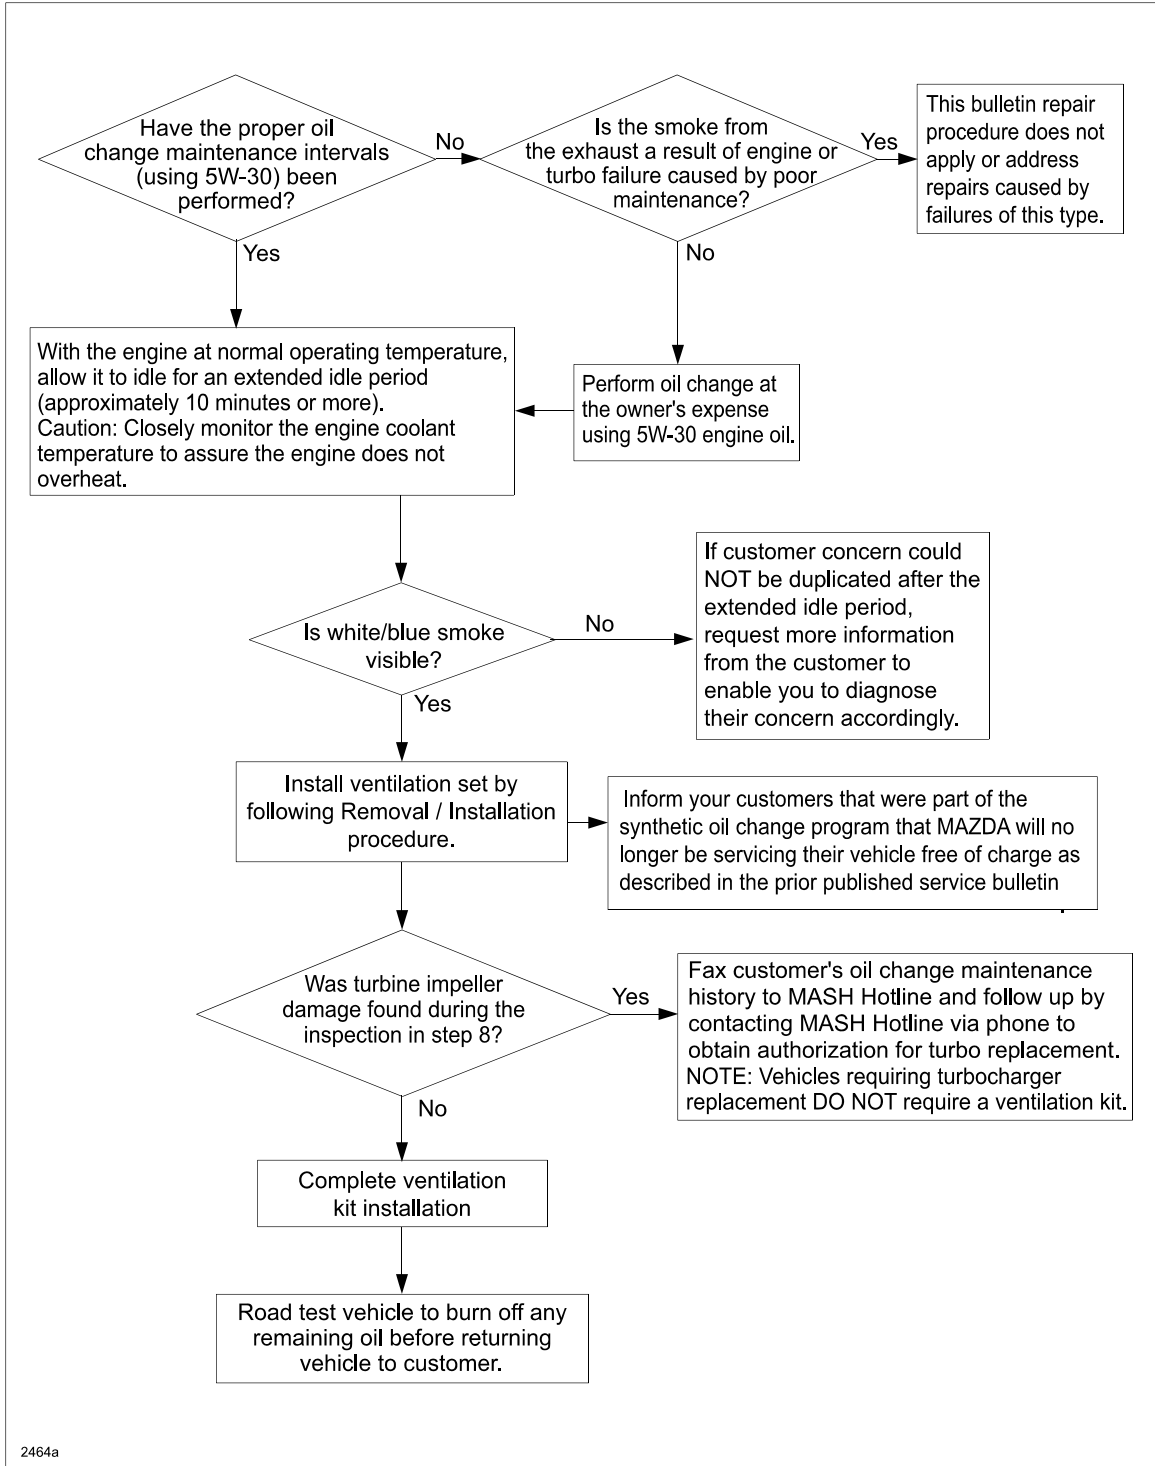
If the proper oil change intervals using 5W-30 have been performed, repair the vehicle using the following repair procedure.

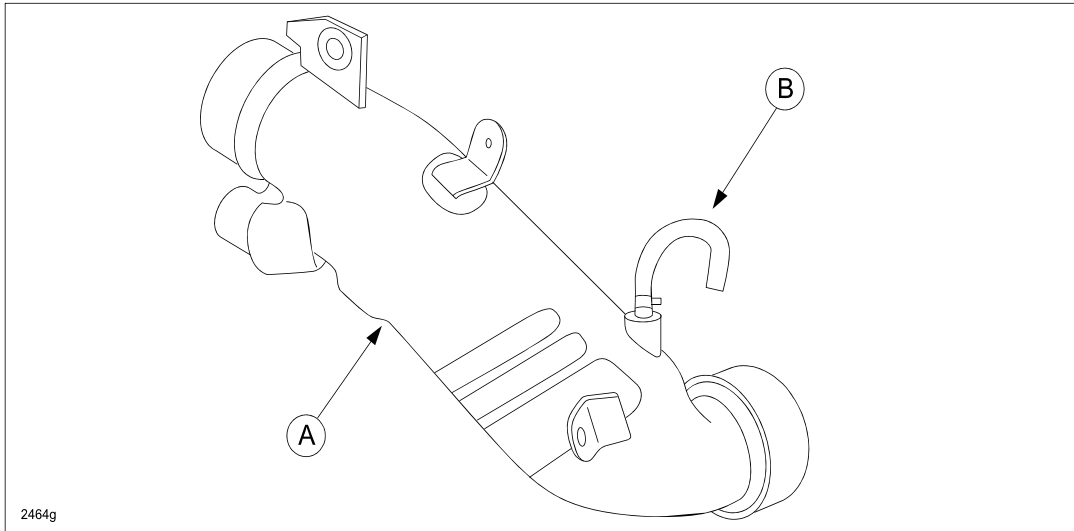
8. Inspect turbocharger for impeller contact damage due to bearing failure.

7. Remove the air pipe (A) with vacuum hose (B).

- If impeller damage is found, discontinue the ventilation kit installation procedure. Contact the Technical Assistance Hotline for turbocharger replacement authorization.
- If impeller damage is not found, proceed to next step.
